11 December 2008

NAVY MEMORANDUM FOR THE RECORD

Subj: CONCEPTUAL SITE MODEL FOR THE REMOVAL OF THE SANITARY AND STORM SEWERS
AT HUNTERS POINT SHIPYARD, SAN FRANCISCO, CALIFORNIA

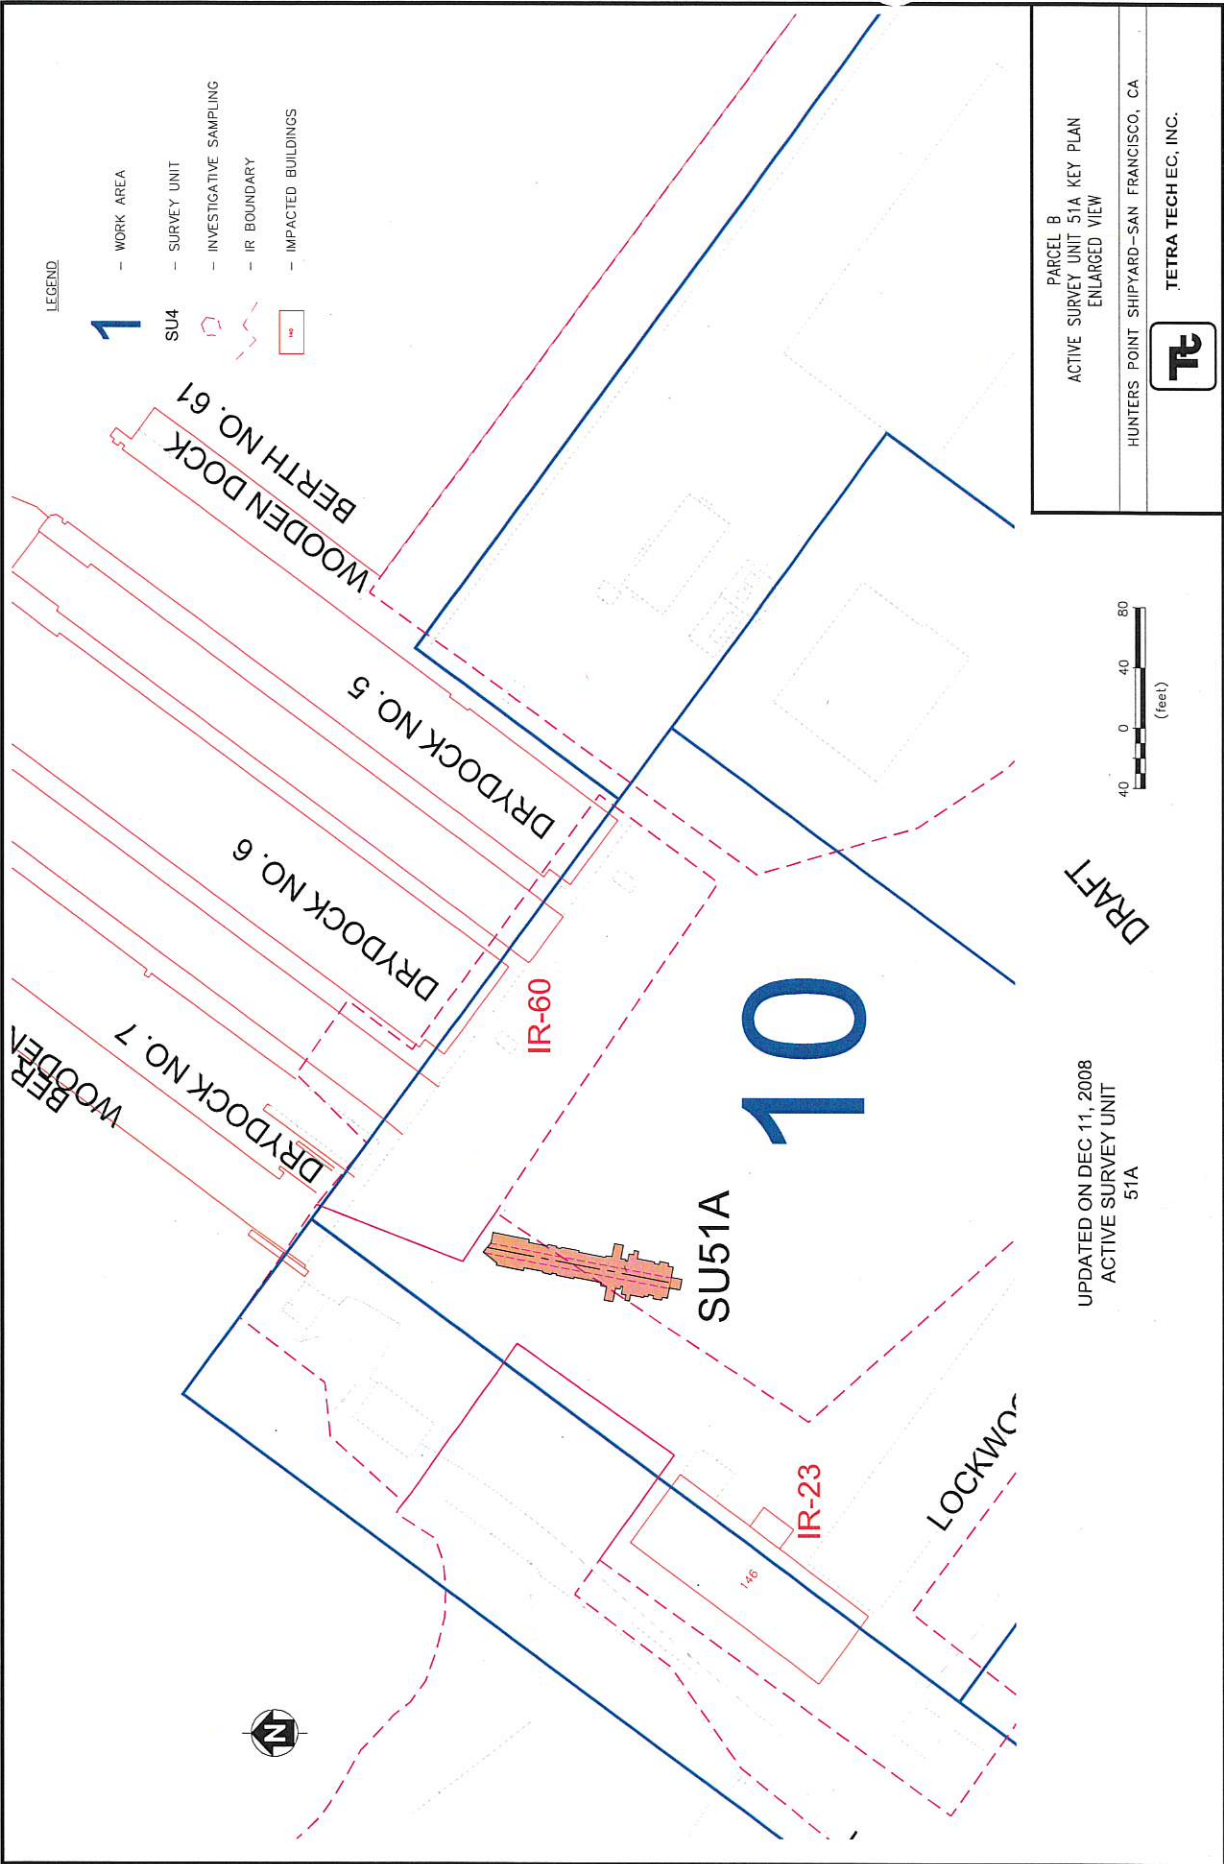
(3) Trench Unit 51A - Cs-137 in pipe and Ra-226 in peripheral material.

(a) Trench. The trench is 124 linear feet in length. Pipe elevations ranged from 4 ft bgs to 6 ft bgs. There was one manhole in the trench, the bottom of which was 6.5 ft bgs. Original remediation depth was 6 to 7 ft bgs. Current post remediation depth is 12 to 16 ft bgs.

(b) Excavated Material. Material was excavated from this trench in February and March 2007. Although some material was segregated as LLRW, most of the material was radiologically cleared and is being held pending use as backfill. Additional analysis of elevated radium-226 samples is being conducted to review the ratio of Ra-226 and U-238.

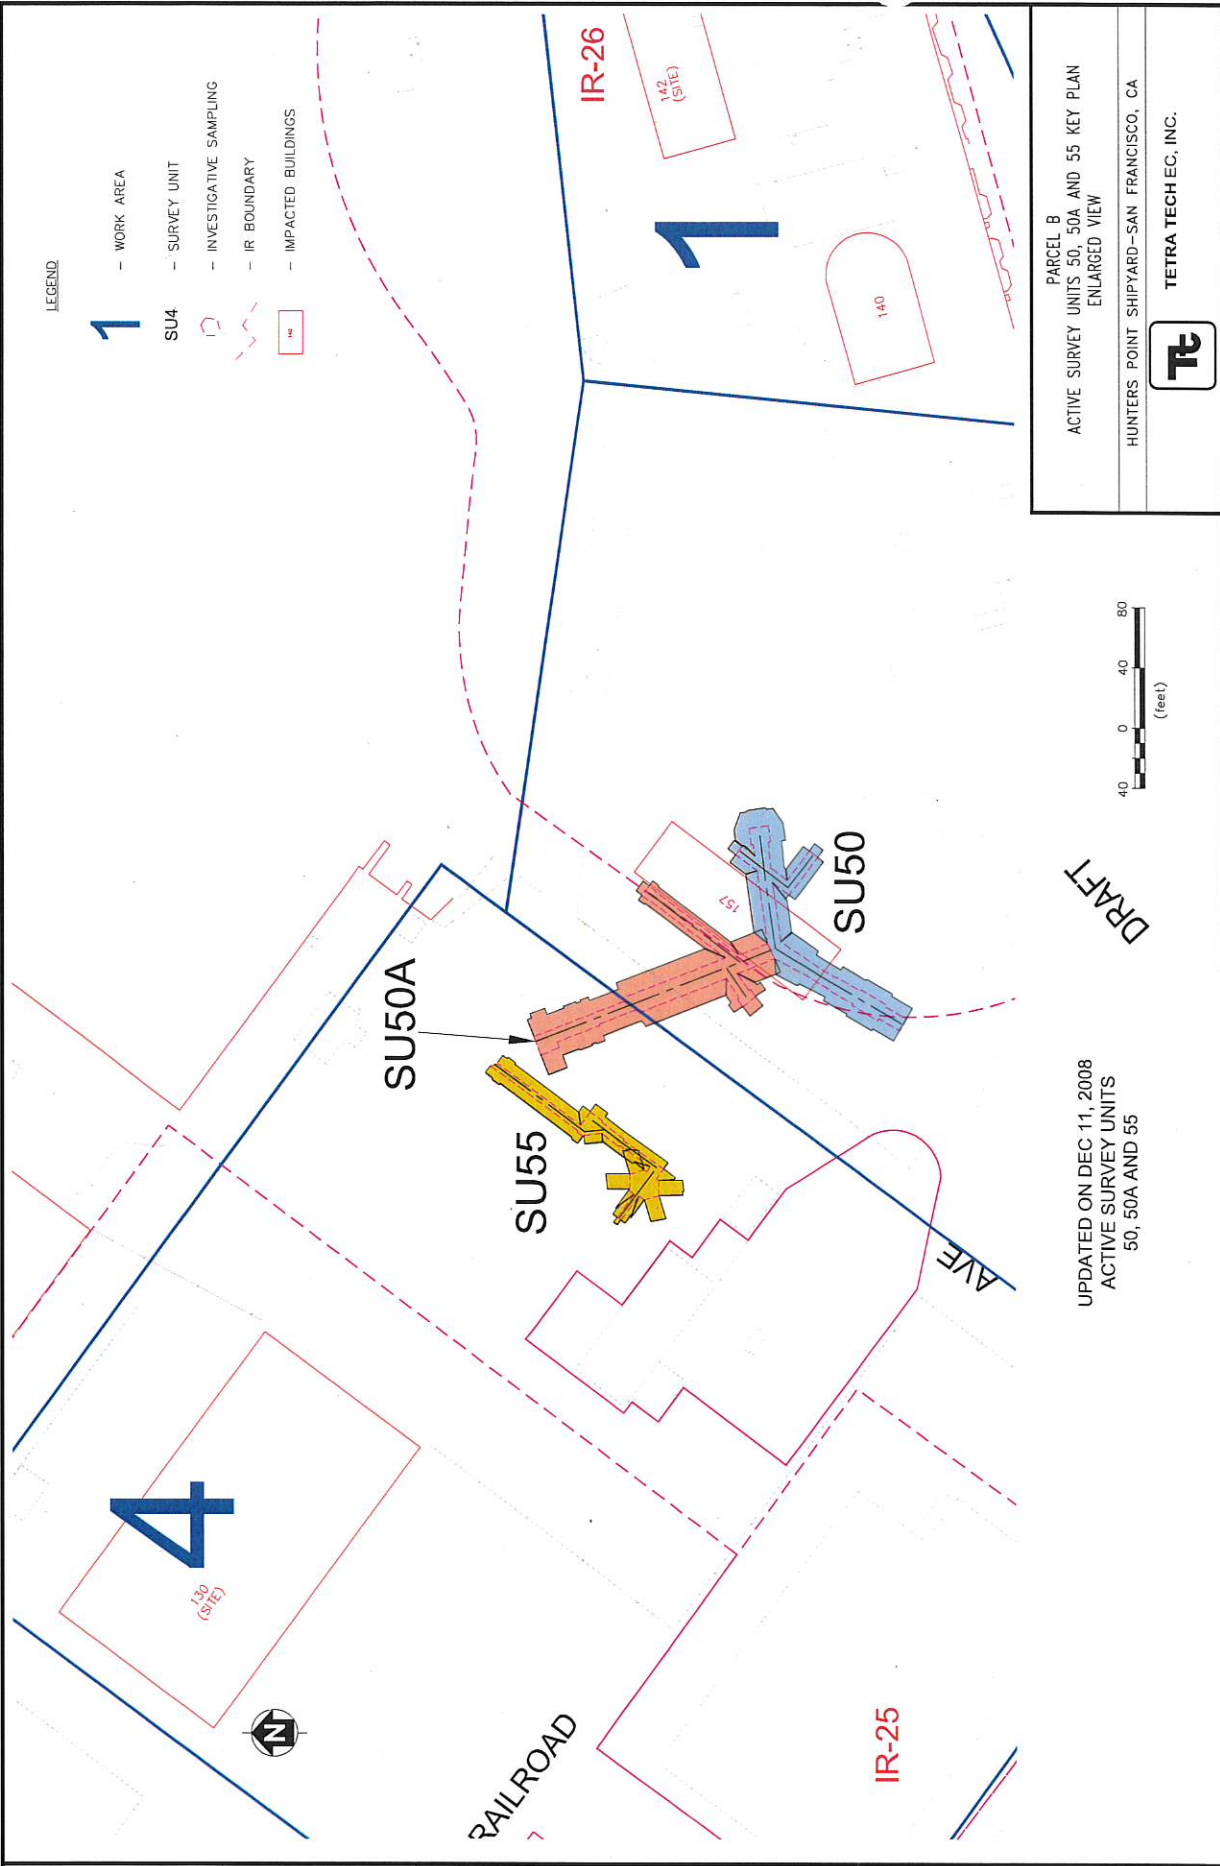
b. The 6.2 percent of Parcel B sewer surveys units still in question currently consists of four trenches that have not yet been radiologically cleared. These "stubborn trenches" were the result of removal of storm sewers. In the "stubborn" trenches two of the removals found Cs-137 contamination in the pipe sediment and all four trenches have found Ra-226 contamination in the surrounding materials, 95% of which has been below 5 feet below ground surface (bgs) which appears to be consistent with pipe depths. Enclosure (2) provides maps of these trenches.
